Central Florida Testing Laboratories, Inc.*Testing Development and Research*

Re: Ground Stabilization Monitoring Solana Bay Townhomes
Bldg. #13, Tampa, Florida
Unit Nos. 8447, 8449, 8451, 8453, 8455, and 8457
American Capital Assurance Corp. Claim No. 141079-111005
CFTL Report No. 209803

Sinkhole Stabilization Report for Solana Bay, Building #13
CFTL Report No. 209803

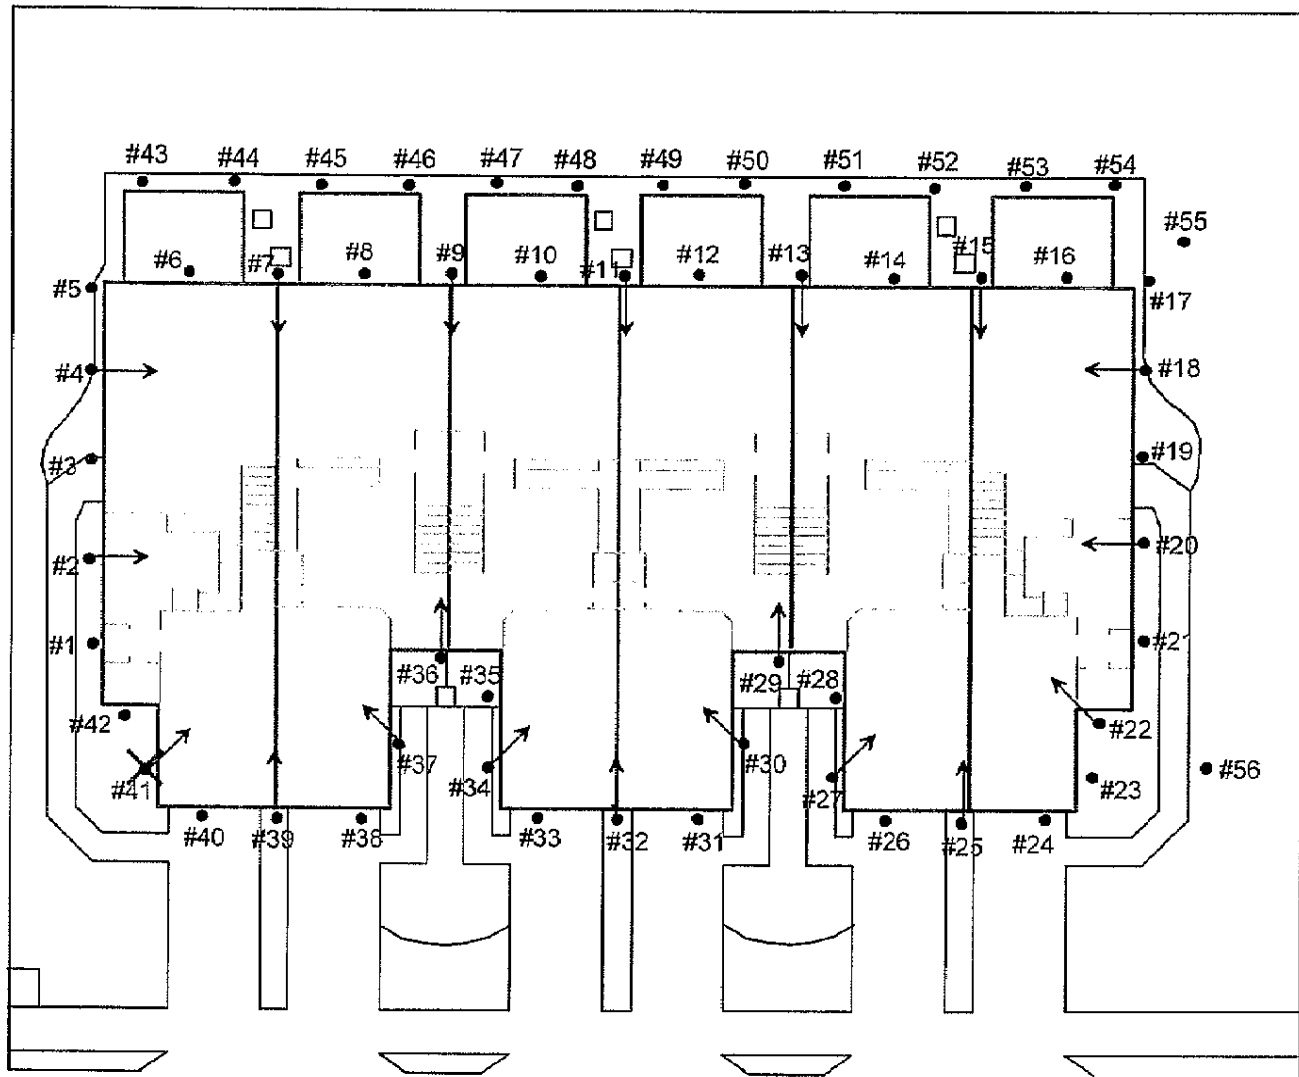
GROUT AS-BUILT

The primary, deep subsurface grouting of the sinkhole remediation program for Building #13 was performed by LRE in a total number of 21 working days between the dates of January 15th, 2013 and February 25th, 2013. This consisted of the deep grouting around the perimeter of the structure through 55 deep injection locations. Alternating injection points forming the perimeter of the building were angled towards the center to better address the raveled soil zones beneath the existing footprint of the building. Our monitoring efforts recorded the specific depths, grout quantities, and locations of each of these 55 locations. This data is presented in graphic form on the attached schematic and in tabular form on the deep grouting summary sheet. While initial recommendations called for 56 deep injection locations, it should be noted that a single location, DG-41, placed near the northwest corner of the building, was eliminated as a result of a conflict with underground utilities.

After final review and correlation of the deep grouting data, two isolated areas of interest were identified as requiring an increase in the amount of injected grout necessary to affect stabilization. Adjacent deep injection locations DG-7 through DG-10 and DG-47 through DG-49, located near the middle of the east wall of the building, accepted a total grout take of 215.7 cubic yards of cementitious grout while deep injection location DG-21, placed along the southern wall near the southwest corner of the building required a total quantity of 40.8 cubic yards of grout. These two areas accounted for approximately 56.9% of the total volume of injected grout while only accounting for approximately 14.5% of the total number of injection locations. The volume of grout used to complete the deep grouting phase of the stabilization program was above our initial estimate of 300 cubic yards. As discussed above, the amount of grout utilized along the east wall of the building was not anticipated in our original estimates and if known this finding would have increased the estimated amount of grout needed to affect full stabilization. Adhering to the limiting criteria of pressure and/or structure lift allows us to conclude the grout quantity was sufficient to affect full stabilization.

component polyurethane grout, were injected through 155 shallow grouting locations placed around the perimeter of the foundation of the main building, along the interior common bearing walls between the units and around the perimeter of the rear porches of Building #13. The locations of the shallow grouting are designated with a solid red line on the attached Grout As-built sheet.
